# WATER DAMAGE RESTORATION

TUKWILA, WASHINGTON

Residential Restoration Case Study

Sewage Backup &  
Basement Flooding

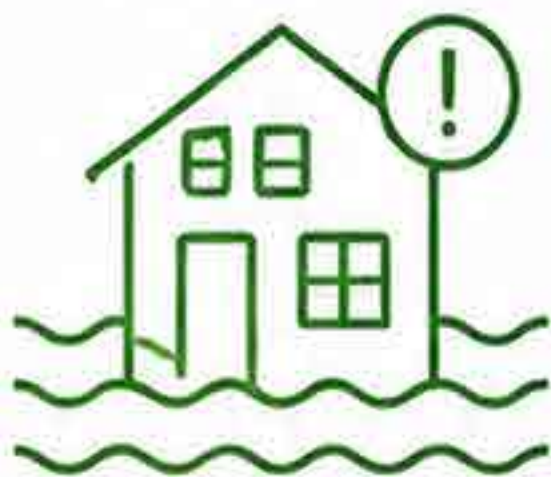
A sudden plumbing failure sent contaminated **Category 3 water** through a residential bathroom and into the lower living areas of a Tukwila property. Because sewage backups contain harmful microorganisms and biohazards, this situation created **immediate health risks** and required urgent professional intervention to protect the residents and the building structure.

The black water spread beyond the bathroom floor tiles, soaking into the subflooring, closet walls, and nearby carpeted areas. Without fast action, this type of moisture can cause **rapid structural damage**, wood rot, **mold growth**, and poor indoor air quality throughout the home.

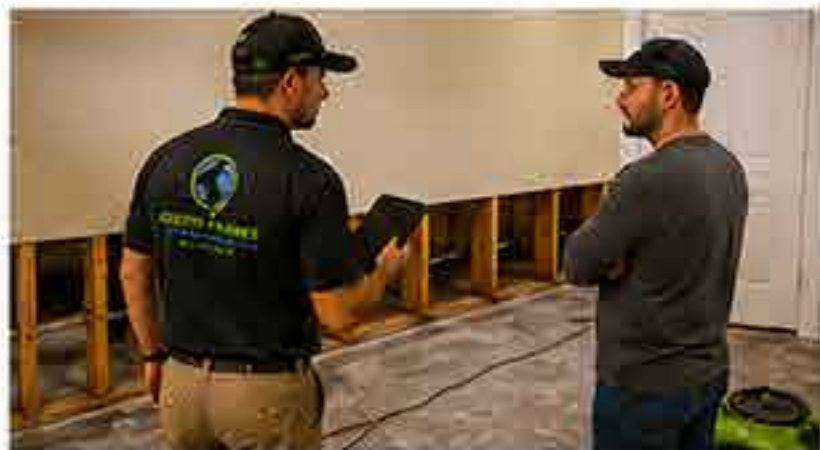
01

## IMMEDIATE ARRIVAL AND OCCUPANT ASSESSMENT

Disaster response demands clear communication. Upon arriving within 45 minutes, our crew chief immediately met with the property owners to walk them through the safety steps. Our team assessed the living conditions of the occupants, explained the health risks associated with Category 3 black water, and detailed how we would isolate the hazard to keep the rest of their home secure.

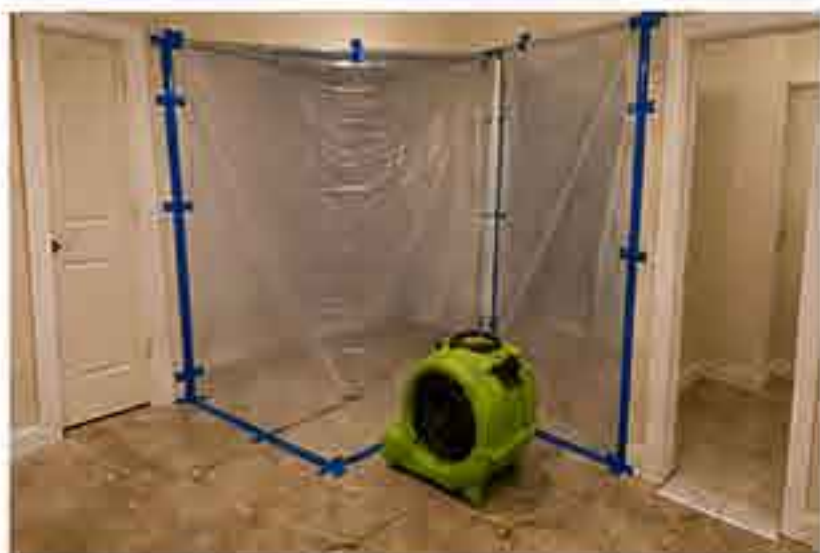
02

## STRUCTURAL CONTAINMENT AND CRITICAL BARRIERS

Before a single piece of machinery turned on, our technicians built strict structural containment zones. Using heavy-duty plastic sheeting and tension poles, the team constructed critical barriers around the entire bathroom and affected lower rooms. This isolated the black water zone from the clean, unaffected areas of the house. We then established negative air pressure using HEPA-filtered air scrubbers to trap airborne particulates, preventing dangerous odor spores or pathogens from traveling into the upper-level breathing zones.

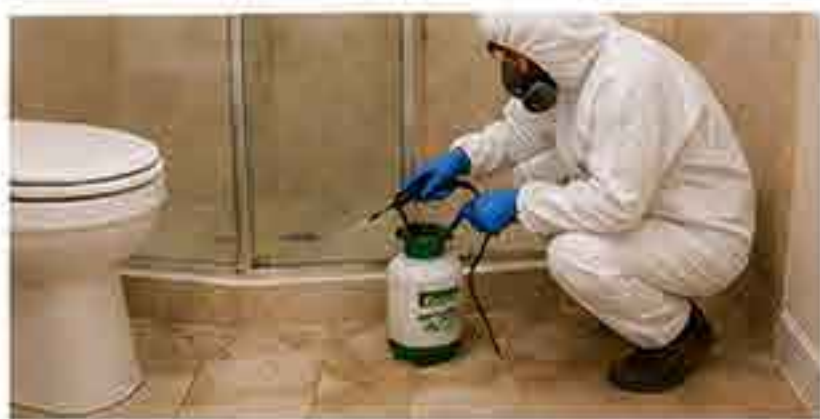
03

## SANITIZATION AND DECONTAMINATION

With containment locked down, crew members donned full-body protective suits and advanced respiratory gear to begin direct remediation. Using professional-grade compression sprayers, the team applied EPA-registered disinfectants across the toilet area, walk-in shower basin, wall tiles, and glass partitions to neutralize all pathogens on contact.

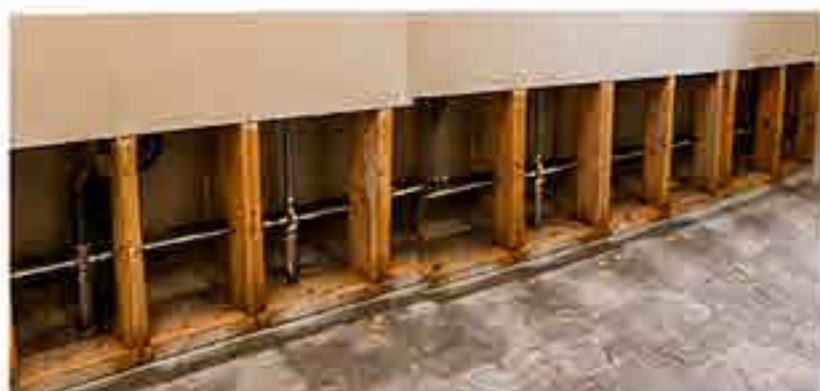
04

## CONTROLLED DEMOLITION

To address water tracking inside the wall cavities, technicians performed precise flood cuts. Removing the bottom two feet of ruined drywall in the closets and adjacent rooms exposed the wet wall studs and sill plates for direct cleaning.

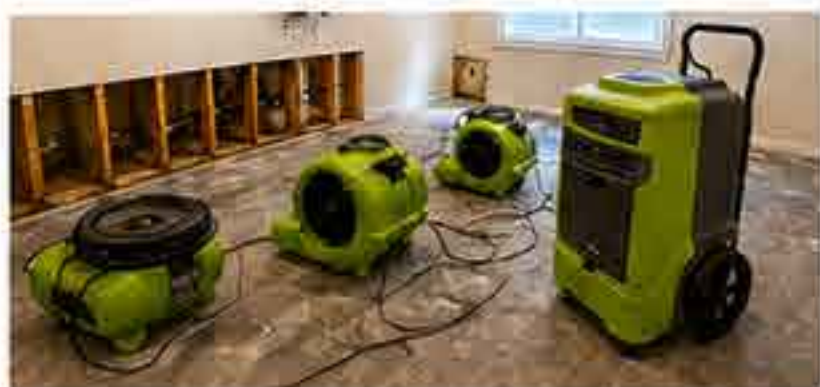
05

## TECHNICAL STRUCTURAL DRYING SETUP

Technicians placed high-capacity low-grain refrigerant (LGR) dehumidifiers alongside a localized setup of centrifugal and axial air movers. This configuration generated high-velocity airflow directly against the concrete slab and wood framing, drawing out deep moisture.

**DEEP CAVITY DRYING:** Concrete foundations and wood studs trap moisture inside dark pockets. Our technicians used digital moisture meters to track the drying progress daily, leaving the equipment in place until every timber met normal regional dry standards.
